Customer
Report Sample

Home
456 New Place
Charlotte NC 28269

Report ID:
110886

Inspection Date
12/12/2008

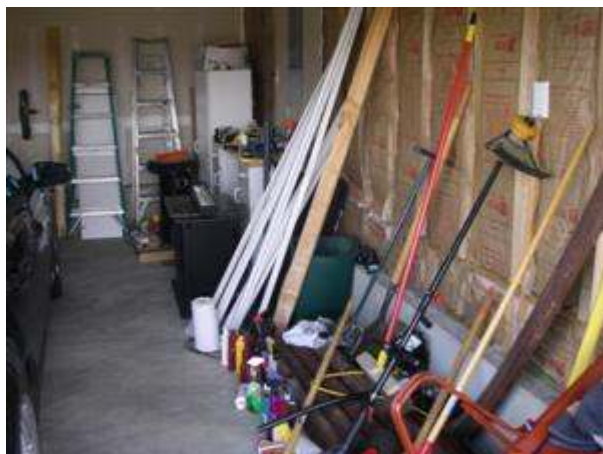
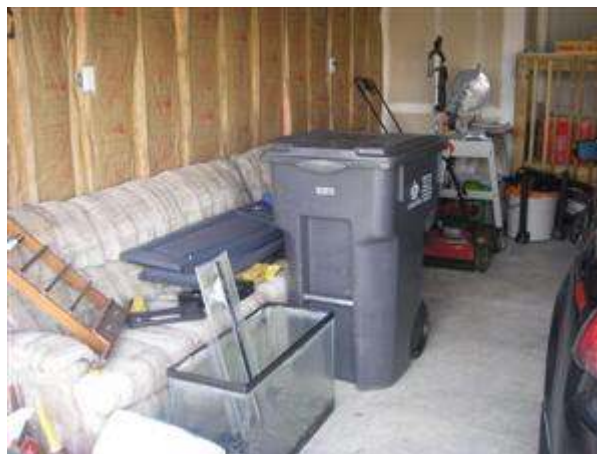
1.5 The property inspection was limited, one or more areas were not accessible due to the following conditions; Furniture, storage and or personal items in numerous areas throughout the property. Supplies, storage and or personal items in cabinets, closets and or utility areas at numerous areas. Washer machine, dryer, cleaning supplies and storage present in laundry room. Areas of the garage foundation and structure could not be inspected/viewed due to cabinets, storage and or personal items. Areas of the attic and roof structure/framing could not be inspected/viewed due to the presence of storage and or personal items. Areas of the attic and roof/ceiling structure/framing could not be inspected/viewed due to the presence of insulation covering components, structural members and or lack of flooring. The crawl space sub-structure/framing/footings at, around, above and behind the floor system insulation could not be inspected/viewed due to the presence of ground vapor barrier, installed insulation, plumbing pipes, drain lines, duct work, mechanical equipment and or earth.

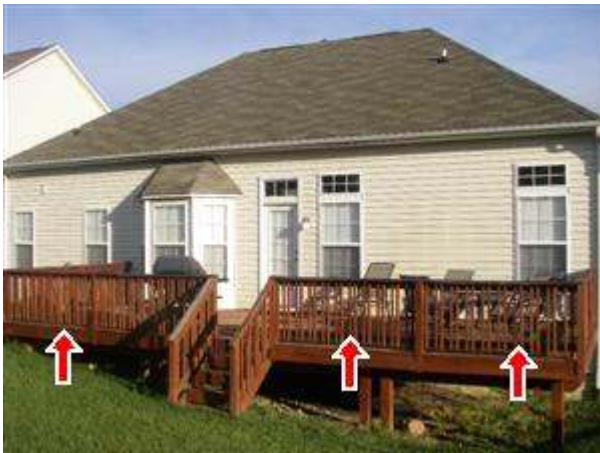
2.2 Picture 1

The rear deck handrail pickets are missing and or are spaced too far apart. Pickets need to be installed at all railings with maximum space between pickets to be four inches or less (where platform exceeds 30 inches from ground).

2.2 The rear deck handrail pickets are missing and or are spaced too far apart. Pickets need to be installed at all railings with maximum space between pickets to be four inches or less (where platform exceeds 30 inches from ground).

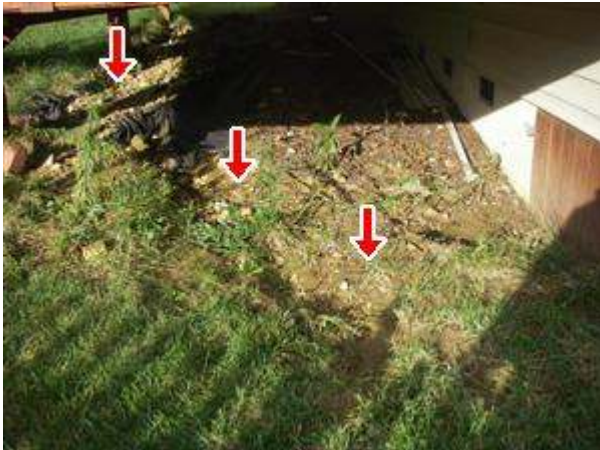
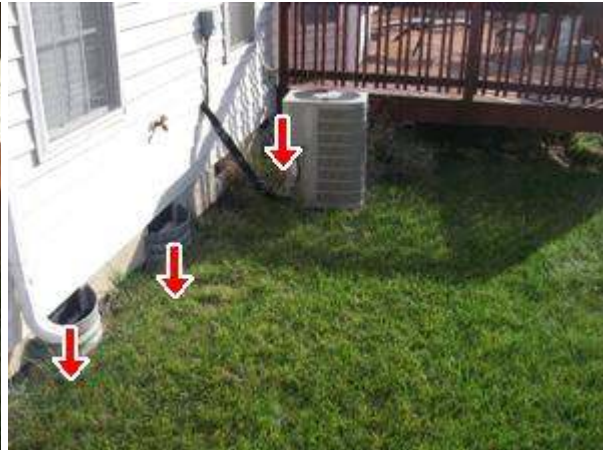
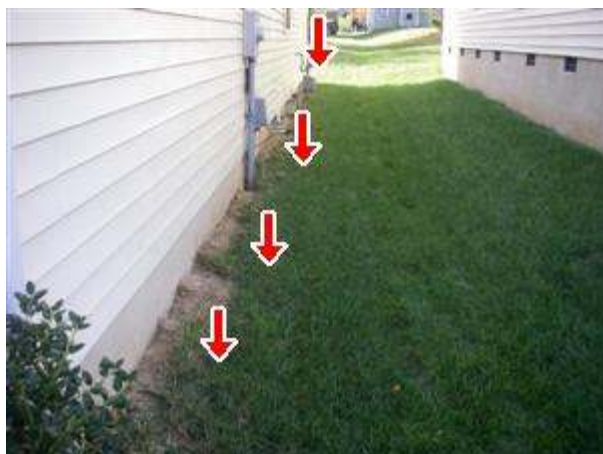
The grading is sloped towards rear and right side of structure. These areas do not allow water to drain freely away from home/foundation. The grading needs to promote positive drainage away from the structure/foundation and should slope down away from the foundation (6 inches per 10 feet, 6" per 6' UBC).

2.3 The grading is sloped towards rear and right side of structure. These areas do not allow water to drain freely away from home/foundation. The grading needs to be promoted positive drainage away from the structure/foundation and should slope down away from the foundation (6 inches per 10 feet, 6" per 6' UBC).

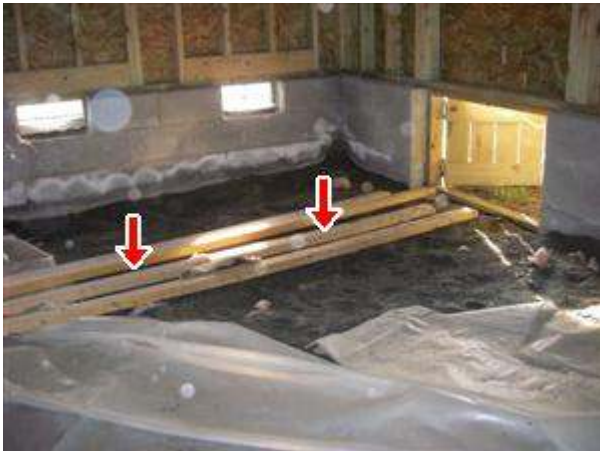
3.0 Picture 1

3.0 All organic and or inorganic type debris on ground in crawl space should be removed.

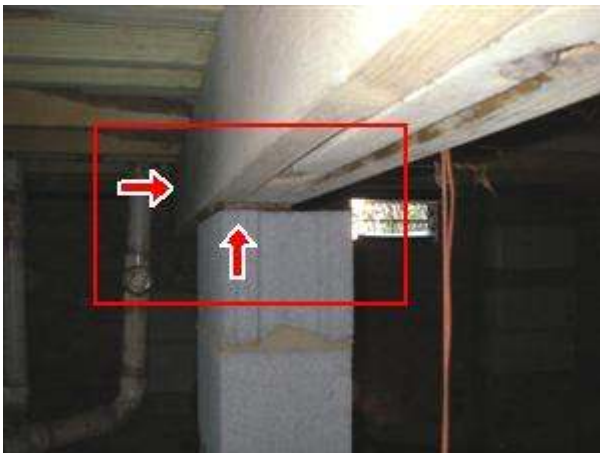
3.1 Picture 1

3.1 (1) One or more of the piers throughout various areas of the crawl space are not aligned under the main structure support beams properly. Evidence suggests that the main beams are not positioned properly on the piers.

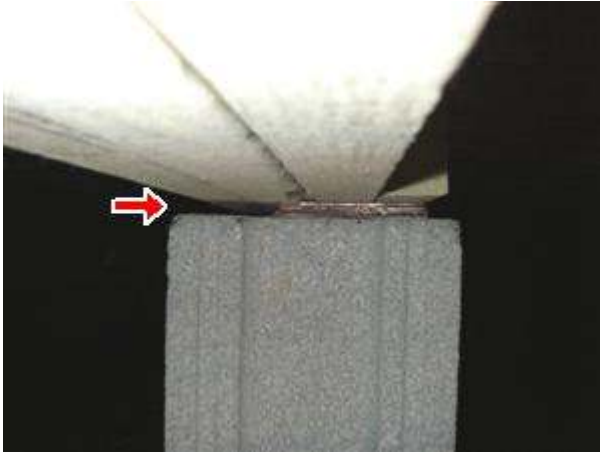
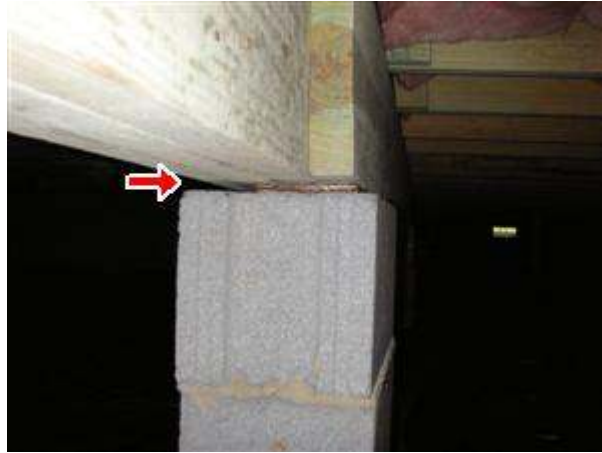
(2) The blocking/metal plate shims between the top of the pier(s) and the wooden structure beams at one or more support piers are not installed properly

(not weight bearing).

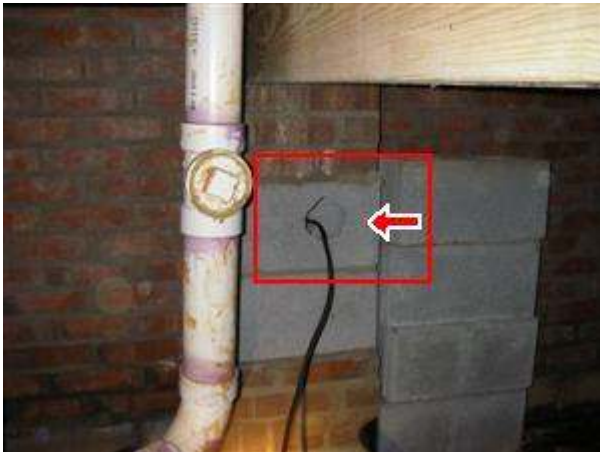
3.1 Picture 4

(3) Pier at right end of drop support girder has been compromised/damaged so as to route a wire through it.

🏠 (3) Pier at right end of drop support girder has been compromised/damaged so as to route a wire through it.

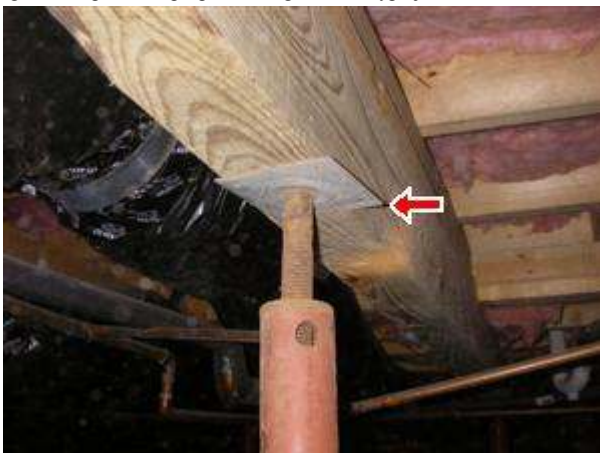
3.1 Picture 5

(4) The masonry structural support piers are compromised, mortar joints are soft, missing, damaged and or deteriorated.

🏠 (4) The masonry structural support piers are compromised, mortar joints are soft, missing, damaged and or deteriorated.

🏠 (5) Screw-type jacks supporting the floor system should be properly attached at the top and bottom to prevent unwanted movement as well as installed right side up and on proper footings. Screw-type jacks are to be used as temporary supports only.

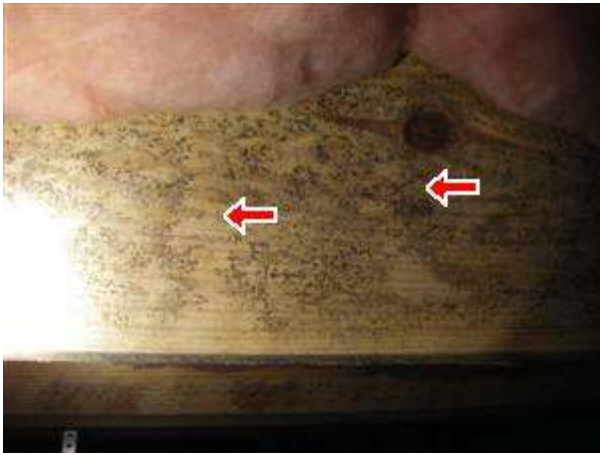
3.2 Picture 1

Noted organic type growth and discoloring of the floor system members is present in various areas throughout the crawl space. Evidence suggests that this is from a poor crawl space environment, typically past and or present elevated moisture/humidity conditions conducive to decaying the substructural member. We recommend review and repair by a properly qualified/licensed specialist.

🏠 3.2 Noted organic type growth and discoloring of the floor system members is present in various areas throughout the crawl space. Evidence suggests that this is from a poor crawl space environment, typically past and or present elevated moisture/humidity conditions conducive to decaying the substructural member. We recommend review and repair by a properly qualified/licensed specialist.

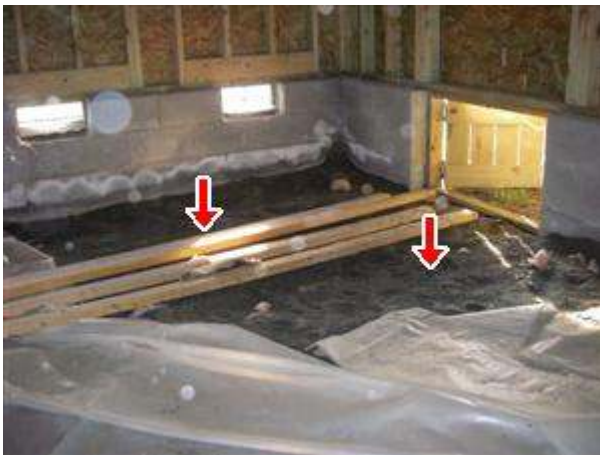
3.4 Picture 1

The crawl space vapor barrier (plastic) is soiled, wet, missing and or deteriorated in areas. A full crawl space ground vapor barrier (plastic) needs to be installed. We recommend a minimum of 6 mil thick plastic. The vapor barrier should be installed in the crawlspace as directed by a properly qualified water/moisture/humidity control specialist.

3.4 The crawl space vapor barrier (plastic) is soiled, wet, missing and or deteriorated in areas. A full crawl space ground vapor barrier (plastic) needs to be installed. We recommend a minimum of 6 mil thick plastic. The vapor barrier should be installed in the crawlspace as directed by a properly qualified water/moisture/humidity control specialist.

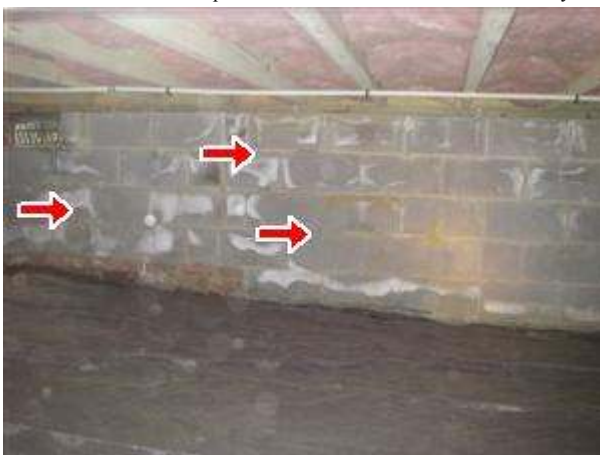
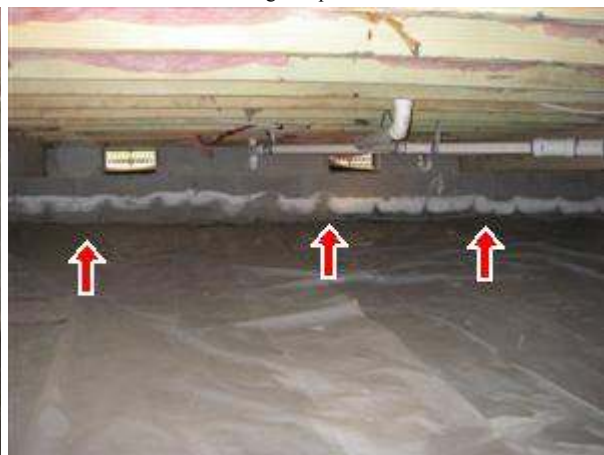
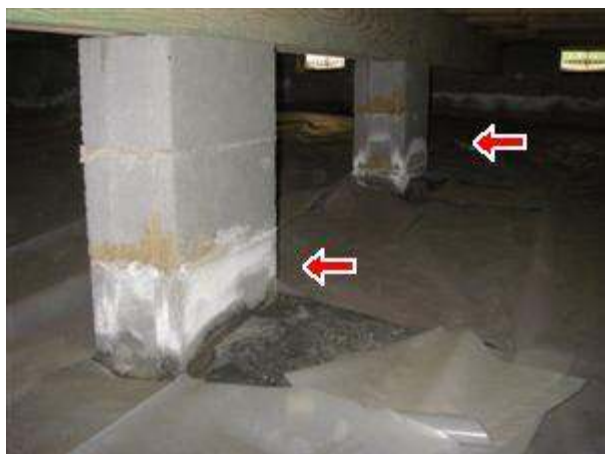
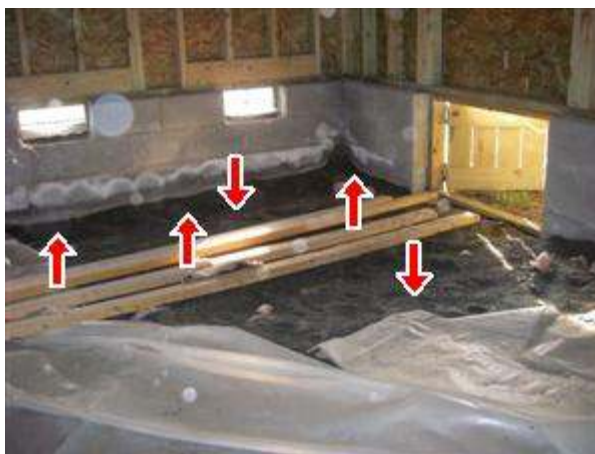
Evidence of water/moisture present inside the crawl space foundation area. The crawl space ground is wet. This water/moisture entry needs to be eliminated to reduce dampness in the structure/foundation that may lead to deterioration of the building components.

3.5 Evidence of water/moisture present inside the crawl space foundation area. The crawl space ground is wet. This water/moisture entry needs to be eliminated to reduce dampness in the structure/foundation that may lead to deterioration of the building components.

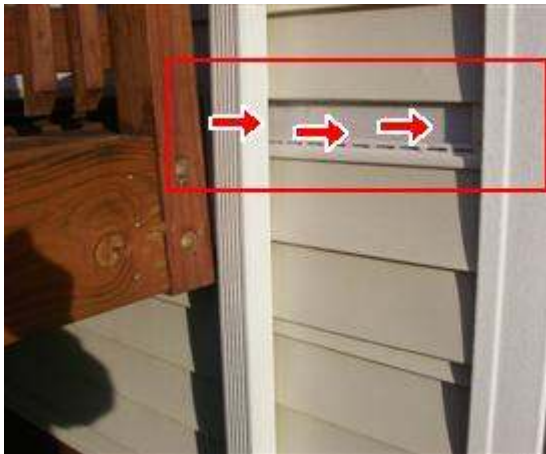
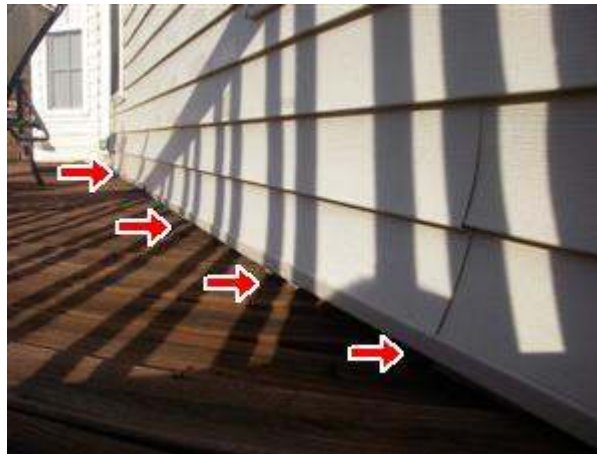
Siding is loose and or missing, this will allow water to penetrate into the framing at, rear and at/around rear deck

4.0 Siding is loose and or missing, this will allow water to penetrate into the framing at; rear and at/around rear deck

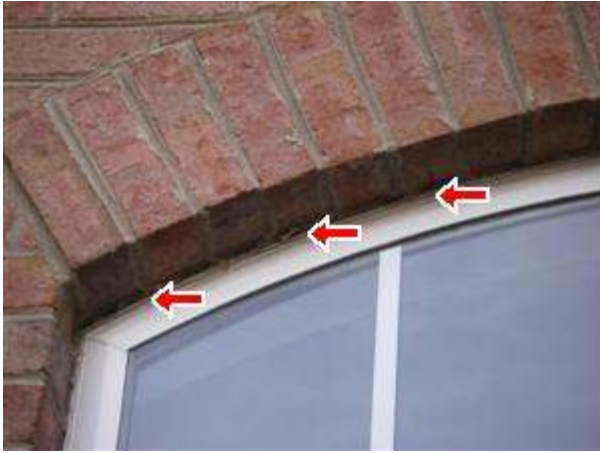
4.1 Picture 1

Caulking around components such as but not limited to windows, doors and exterior wall penetrations at various areas around the house need to be caulked/sealed, open voids and or missing caulking observed.

4.1 Caulking around components such as but not limited to windows, doors and exterior wall penetrations at various areas around the house need to be caulked/sealed, open voids and or missing caulking observed.

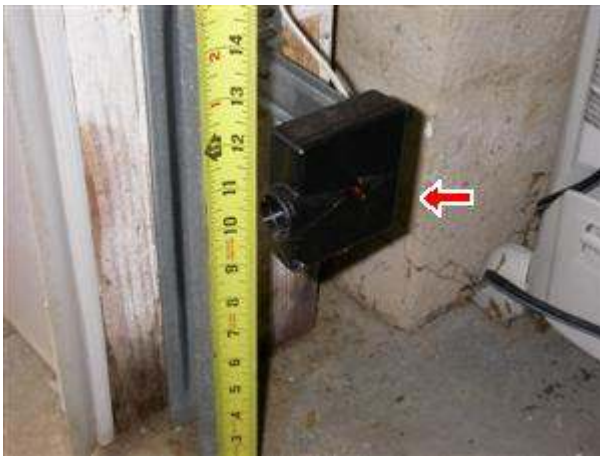
4.7 Picture 1

**4.7** Garage door safety reverse eye sensors are not installed properly, they are installed too high. They need to be installed as per the manufacturer's specifications (safety concern).

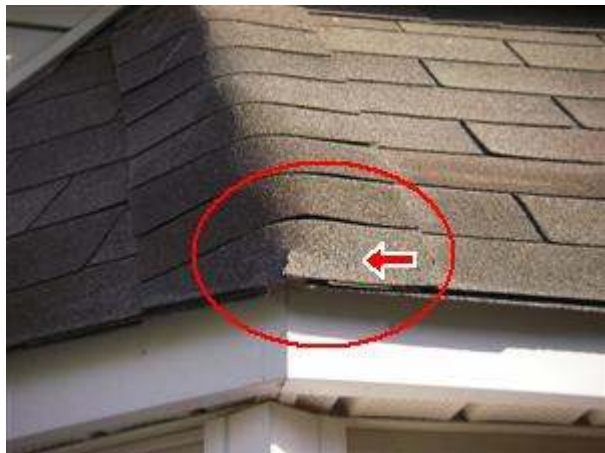
5.1 Picture 1

Roof ridge shingles at rear bay window roof are split/damaged.

5.1 Roof ridge shingles at rear bay window roof are split/damaged.

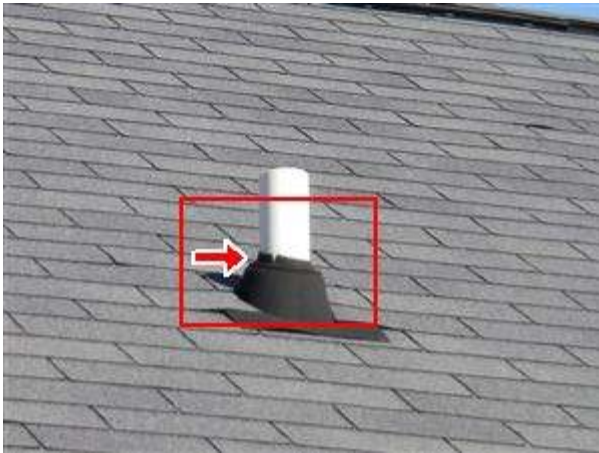
5.3 Picture 1

Roof plumbing vent pipe flashings/boots are split/damaged at rear.

5.3 Roof plumbing vent pipe flashings/boots are split/damaged at rear.

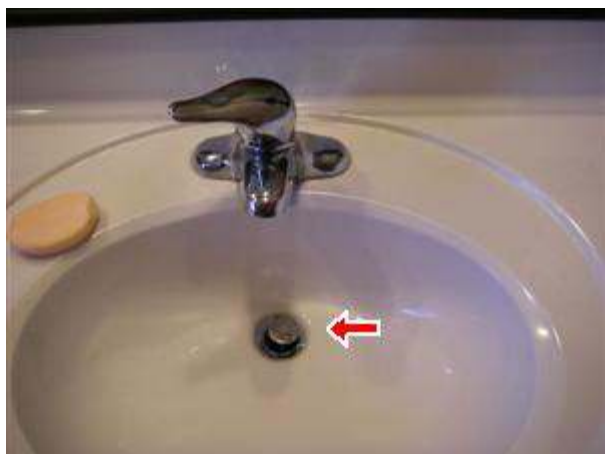
6.4 Picture 1

6.4 (1) The sink stopper in the master bathroom did not work when tested.

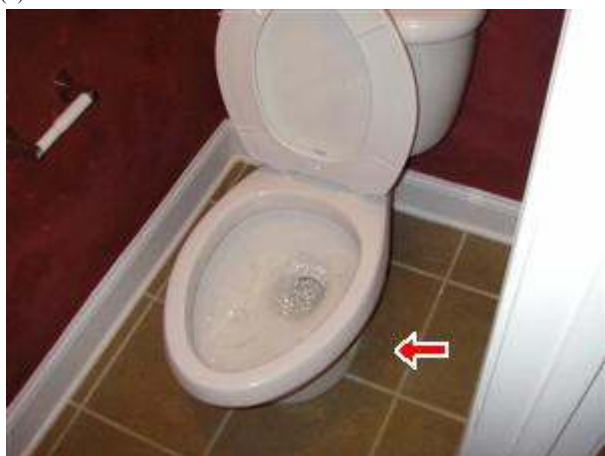
6.4 Picture 2

(2) Toilet in the master bathroom is loose from the floor.

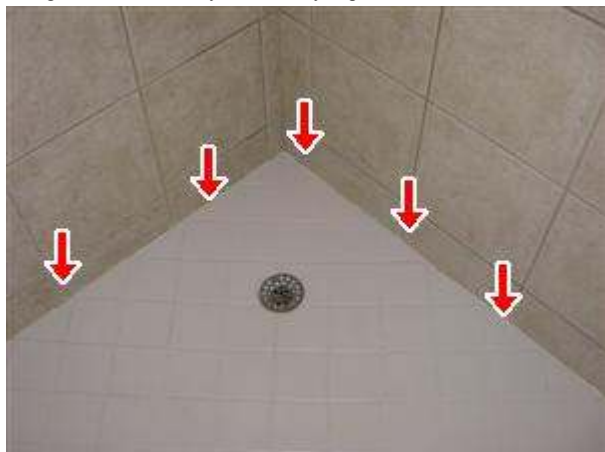
6.5 Picture 1

Cracked/compromised grout joints in the tile walls / floor junctions in the master shower need to be properly re-done/sealed. Non visible moisture damage that is not readily visible maybe present in, under and or around the compromised area, this should be checked during the repair.

**6.5** Cracked/compromised grout joints in the tile walls / floor junctions in the master shower need to be properly re-done/sealed. Non visible moisture damage that is not readily visible maybe present in, under and or around the compromised area, this should be checked during the repair.

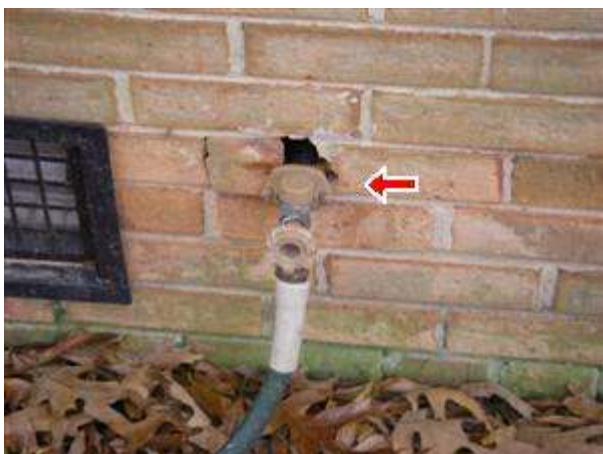
6.7 Picture 1

Hose faucet(s) loose from wall, the faucet(s) at various areas should be secured to the structure.

**6.7** Hose faucet(s) loose from wall, the faucet(s) at various areas should be secured to the structure.

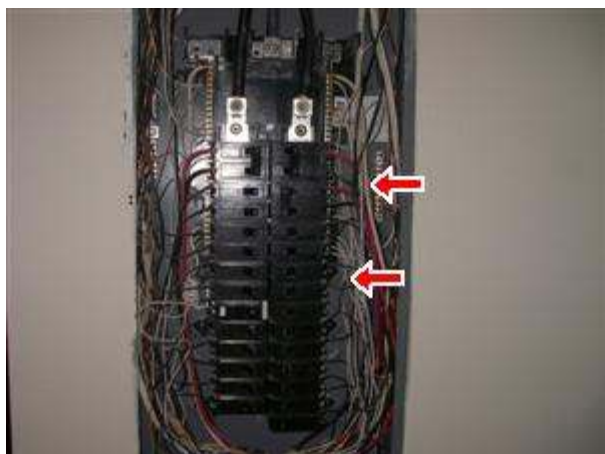
7.2 Picture 1

Two wires were observed to be connected to one circuit breakers in the main panel. While often done, this is not permitted unless the device is so labeled. Double tapping often leads to overloaded circuits and loose connections that can overheat (safety concern).

7.2 Two wires were observed to be connected to one circuit breakers in the main panel. While often done, this is not permitted unless the device is so labeled. Double tapping often leads to overloaded circuits and loose connections that can overheat (safety concern).

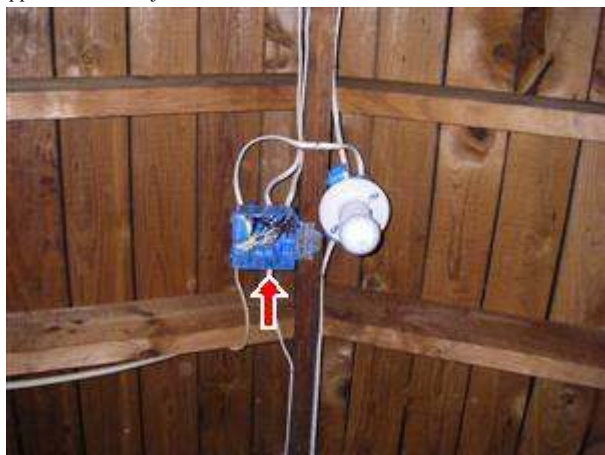
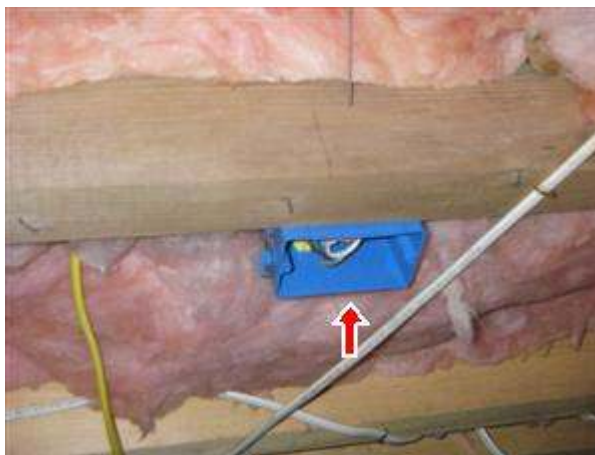
Open wire splices/junction boxes were observed in the crawl space and attic. All wiring connections should be protected in a enclosed/covered approved electric junction box.

7.3 Open wire splices/junction boxes were observed in the crawl space and attic. All wiring connections should be protected in a enclosed/covered approved electric junction box.

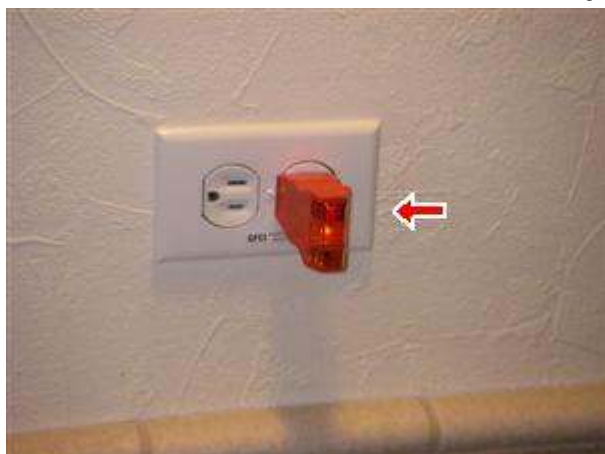
7.4 Picture 1

The GFCI electric outlet in the hall bathroom tested to be improperly wired and did not trip off when tested (safety concern).

7.4 The GFCI electric outlet in the hall bathroom tested to be improperly wired and did not trip off when tested (safety concern).

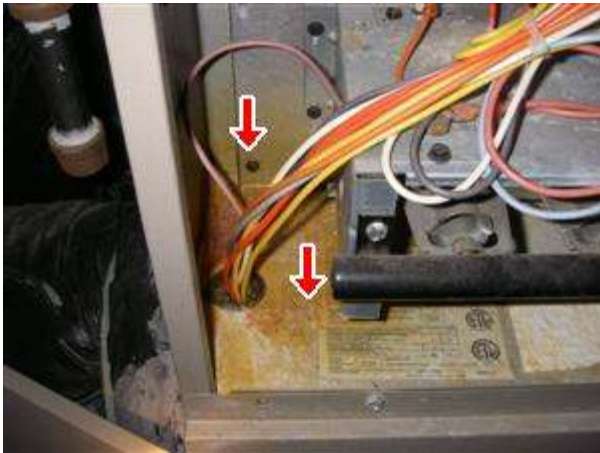
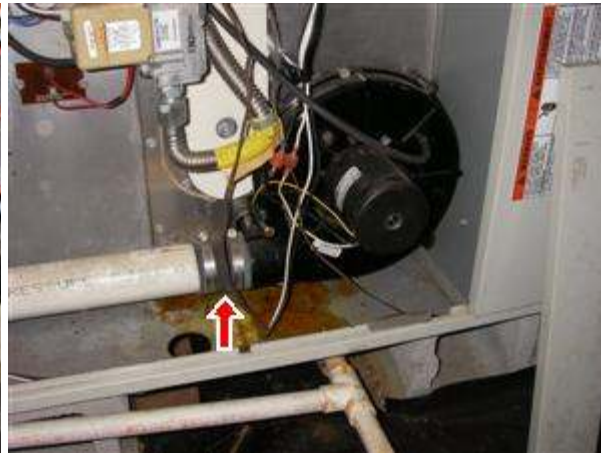
Abnormal moisture stains and rust present inside air handler located in attic.

8.1 Abnormal moisture stains and rust present inside air handler located in attic.

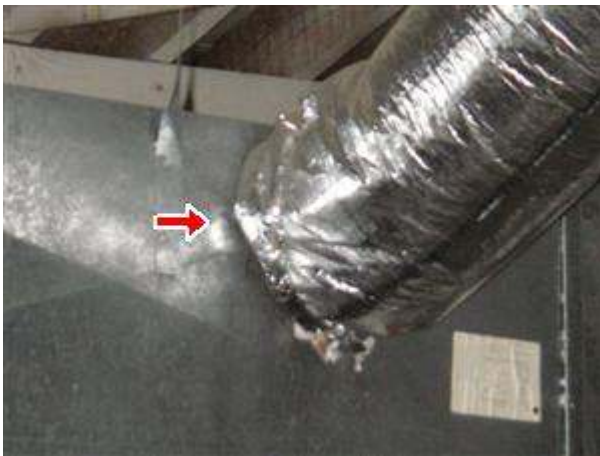
8.2 Picture 1

HVAC system ducts are somewhat loose and not properly sealed at junctions, connections and joints.

**8.2** HVAC system ducts are somewhat loose and not properly sealed at junctions, connections and joints.

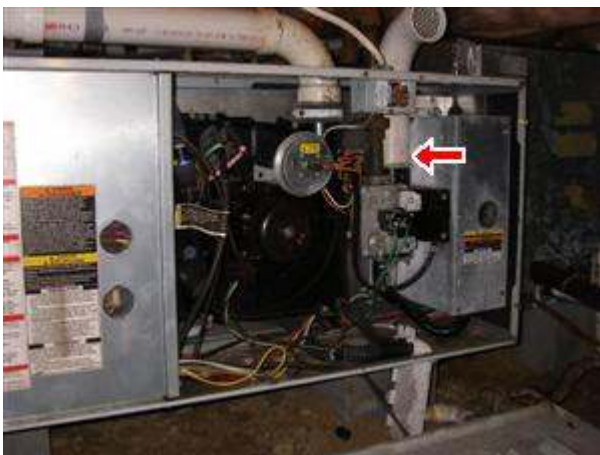
8.8 Picture 1

Investigate Further: Gas odor (smell of gas) present/observed at/near furnace shut off valve/piping at the furnace area (safety concern).

**8.8 Investigate Further:** Gas odor (smell of gas) present/observed at/near furnace shut off valve/piping at the furnace area (safety concern).

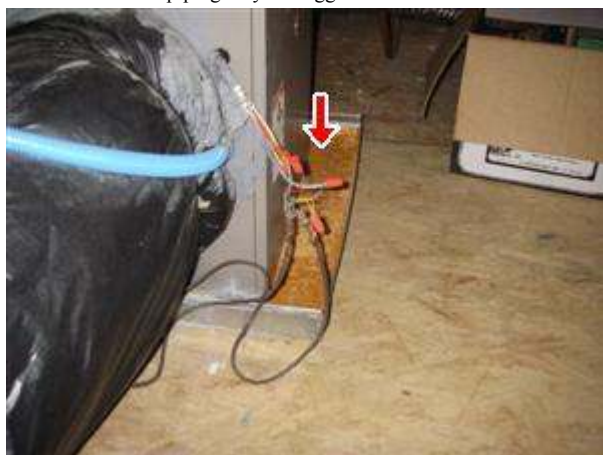
9.1 Picture 1

Evidence of past and or present moisture conditions (rust, water stains and or standing water) present in over flow pan under air handler unit located in attic . This is a typical past and or present indication of the air handler, refrigerant lines and or A-coil leaking and or not draining properly, also the condensation drain piping maybe clogged.

9.1 Evidence of past and or present moisture conditions (rust, water stains and or standing water) present in over flow pan under air handler unit located in attic . This is a typical past and or present indication of the air handler, refrigerant lines and or A-coil leaking and or not draining properly, also the condensation drain piping maybe clogged.

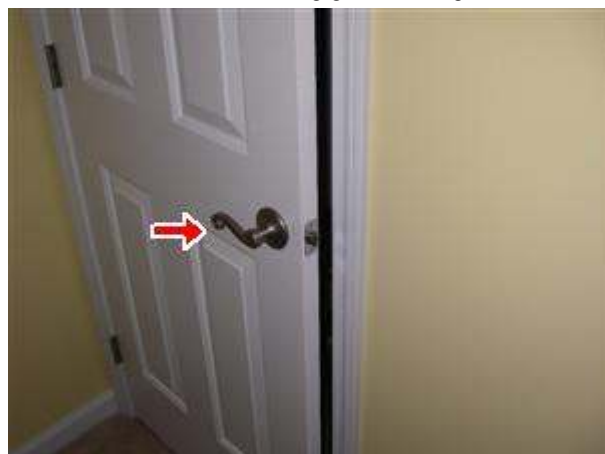
10.3 Picture 1

Door knob latch did not engage into striker plate and should be repaired or adjusted at; master bedroom closet

10.3 Door knob latch did not engage into striker plate and should be repaired or adjusted at; master bedroom closet

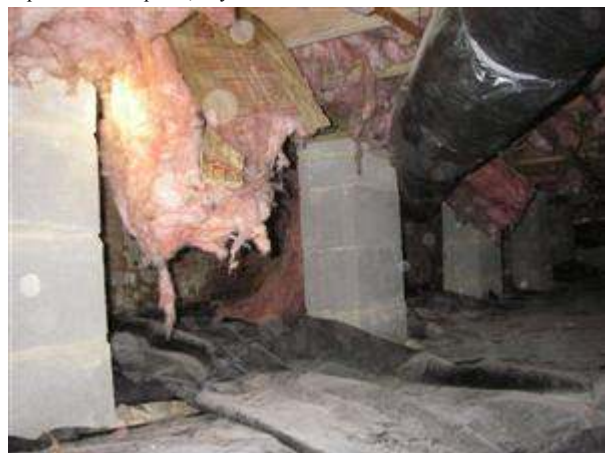
11.1 Picture 1

The crawl space floor insulation has come loose and is laying on the ground at various areas throughout the crawl space. The insulation needs to be put back into place, any wet and or deteriorated insulation needs to be replaced.

**11.1** The crawl space floor insulation has come loose and or is laying on the ground at various areas throughout the crawl space. The insulation needs to be put back into place, any wet and or deteriorated insulation needs to be replaced.

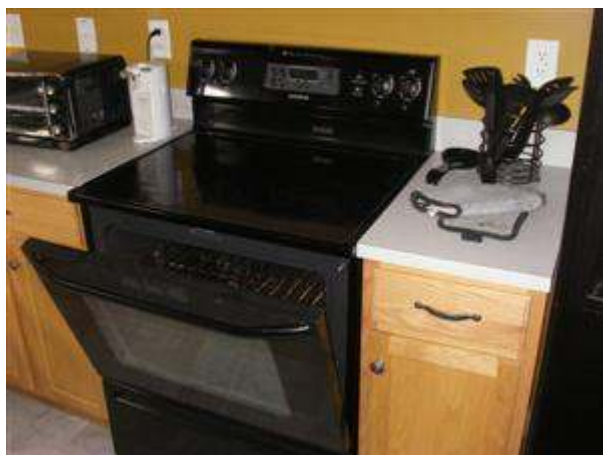
12.3 Picture 1

**12.3** Range/oven anti-tip bracket/anchored is not present. This device can be easily installed and was part of the manufactures installation packet as shown on the oven door label.
